X-bands Baselines Revisited

Project TBASERDN030625x, June 25, 2003

R. Norrod, R. Fisher

June 27, 2003

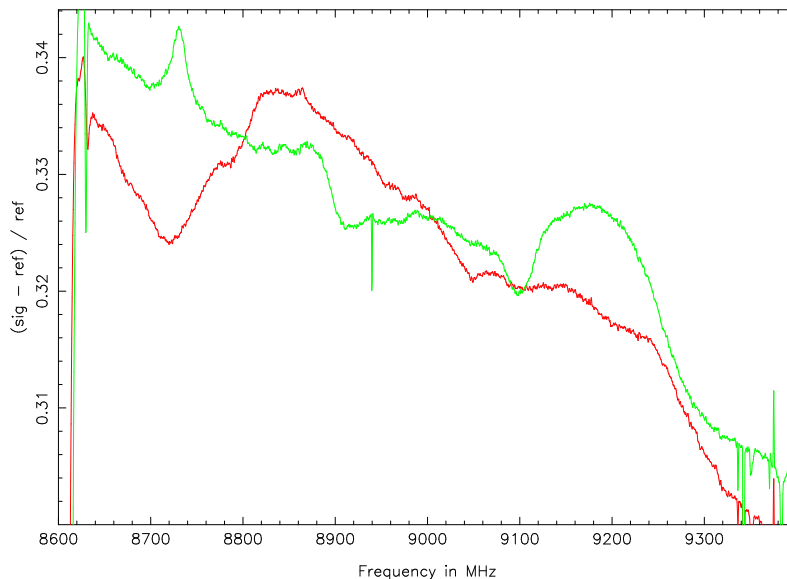
Figure 1 shows the results of an on-off observation of 3C218, and for comparison Figure 2 reproduces a figure from Dana's report on the January 17th observations, on 3C48. Figure 2 results are typical of those which have been seen through May with this receiver. The vertical range of Figures 1 and 2 are the same, as a fraction of the source temperatures. The baselines today, while certainly not flat, are significantly smoother than earlier ones. The reasons this might be are discussed in the next session.

During the course of the testing, some total power instability was noticed in the LCP (red in the figures) channel. Subsequent troubleshooting identified a broken IF cable which probably was the source of the instability. This could have had an effect on the baseline flatness seen on that channel.

Figure 1: $(sig - ref)/ref$, for the X-band LCP (red) and RCP (green) channels, measured on-off 3C218 on June 25. Compare with Figure 2.

The most likely explanation for the improvement in continuum source baselines is that the clean-up of the waveguide joints eliminated highly irregular losses at these joints (or one could think of it as noise with lots of frequency structure leaking into the receiver). The (On - Off)/Off calibration causes any irregularities (even at the fractional kelvin level is significant) in the system noise to show up in the baseline response. Since it is almost impossible to measure in the lab feedhorn loss with the degree of precision needed to see these effects, there is no substitute for extreme care in fabrication, quality control, cleanliness, and assembly of the receiver input waveguide and feedhorn.

- One joint in circular waveguide between the feedhorn and the vacuum window was found to have a mistake that resulted in a 0.015 inch gap in the waveguide wall. The joint was re-machined.

- Several (10-12) metal chips were found in the feedhorn corrugations. These were evidently left from the feed fabrication process.
- The chromate surface finish on the aluminum feedhorn is generally non-conductive, and we became concerned that this thin dielectric layer on the flange faces could be a detrimental factor. Hence, we mechanically removed the chromate coating from all the joint flange faces. (The horn is fabricated in four sections with bolted joints.)

- A second waveguide joint had a noticeable oily film between the flanges. An investigation concluded this was cutting oil from the installation of some helicoil threads when the receiver was off in December 2002, and obviously the joint was not properly cleaned.

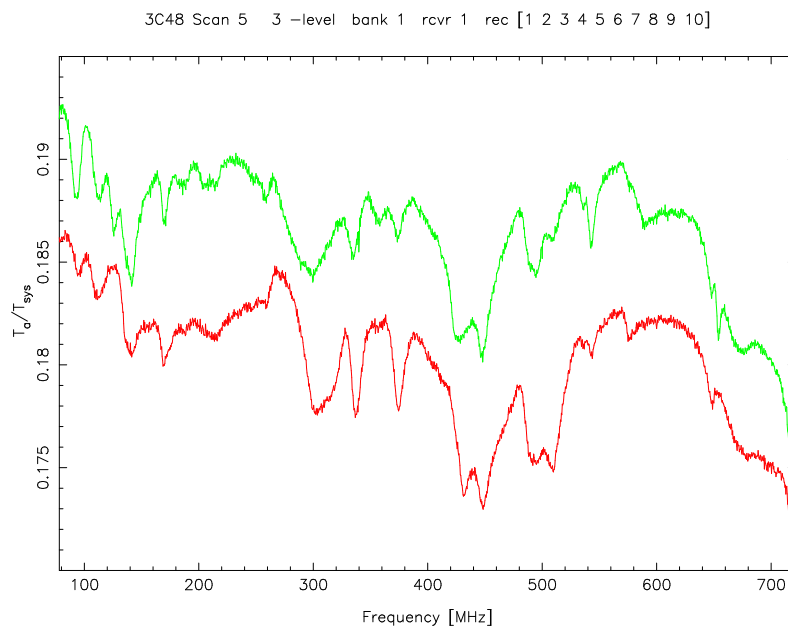
Figure 2: A reproduction of Figure 3 from the report on TBASEDSB030117, January 17, 2003 by Dana Balse. Like Figure 1, the plot is centered at 9GHz.
