# EDTN 201

## Initial Evaluation of Haas Super Mini Mill S/N 40150

NRAO PO 207121

Rev. 2a 28 Sep 2005

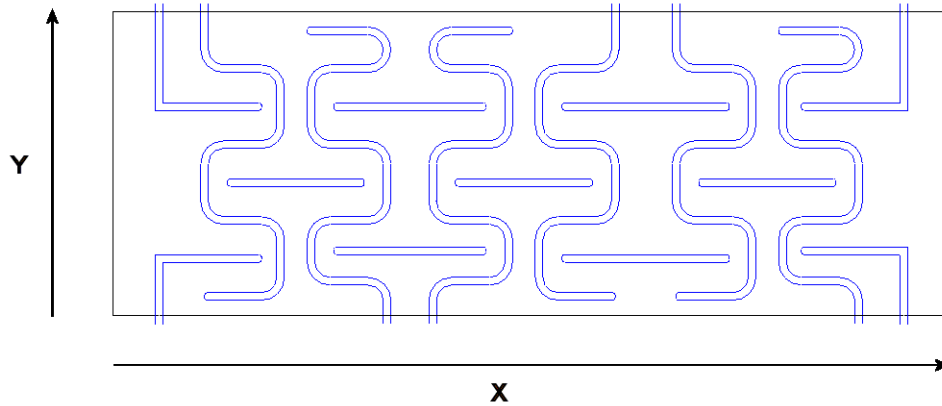
**Fig. 1. Test pattern.**

The test pattern shown in Fig. 1 was machined in type 360 free machining brass. All channels are nominally 0.050" wide x 0.050" deep. After roughing with a 0.040" end mill, finishing cuts were made with a 0.031" end mill. The tool path was chosen so all walls of the channels were climb-cut (this has been found to give the best wall quality). Five test pieces were made using different spindle speeds and feed rates:

1. As shown in Fig. 1. Spindle speed 8000 RPM, feed rate 4"/min.
2. Test piece 1 with a final 2 mil surface trim to remove any distortion near the top of the channel. The trimming cut followed the perimeter of the channels, always climb-cutting, to remove burrs.
  - A. Same as test piece 1 but 5000 RPM and 4"/min.
  - B. Same as test piece 1 but 8000 RPM and 2"/min.
  - C. Same as test piece 1 but 4000 RPM and 2"/min.

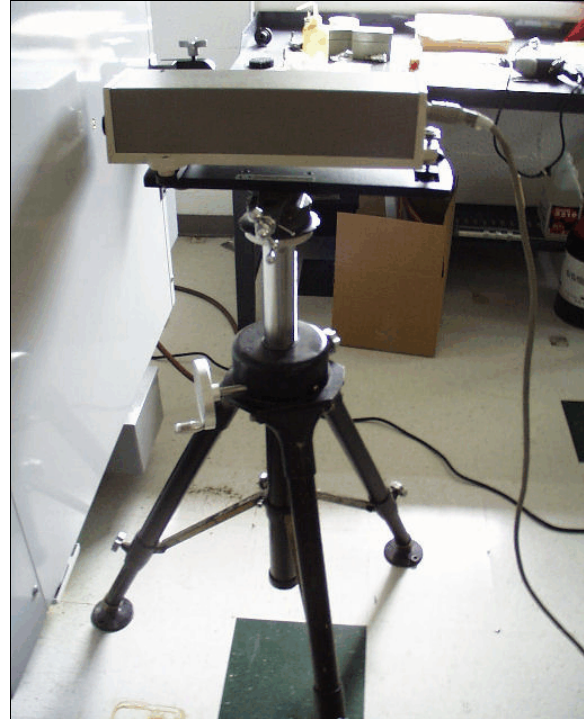
Measurements were made on the Haas mill using the Green Bank HP 5508A laser interferometer. This instrument has a resolution of  $10\ \mu\text{in}$  and is stable to less than  $10\ \mu\text{in}$ . The beam from the laser (Fig. 8) passes through a combined beam splitter and retroreflector attached to the table of the mill (Fig. 9). Part of the beam is reflected back to the laser unit and part of it is transmitted to a second retroreflector mounted on the spindle of the mill where it too is reflected back into the laser unit. The interferometer readout (Fig. 10) indicates the distance between the two retroreflectors.

**Fig. 8** Laser unit of the HP interferometer as set up for measuring the X-axis. The laser beam enters the mill through a small hole in right cover.

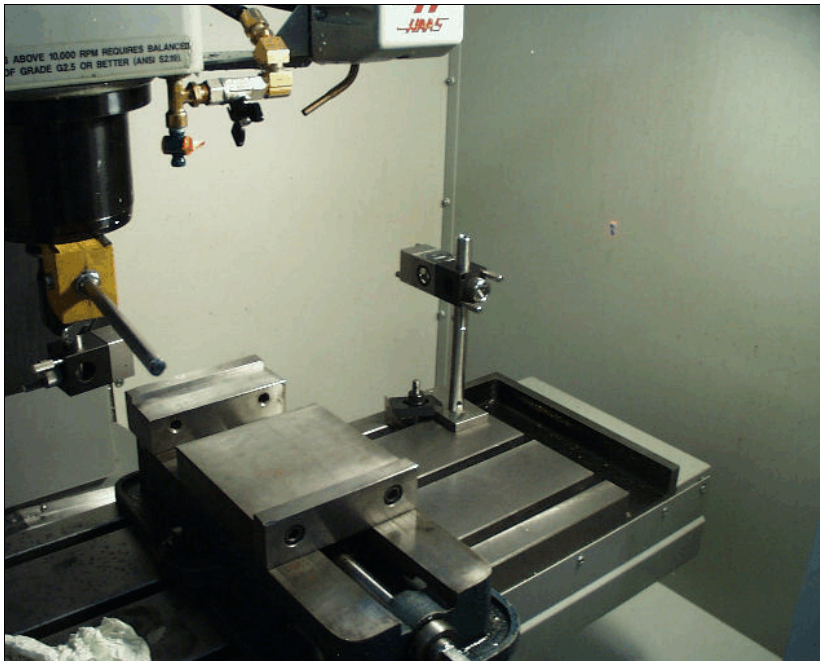
The photographs show the setup for measuring the X-axis of the mill. Y-axis measurements are set up similarly, with the laser beam entering the mill through the door of the housing.

**Fig.9** Setup for the X-axis measurements. The beam splitter and retroreflector are at the right on the table of the mill. The retroreflector at the left is attached to the spindle.

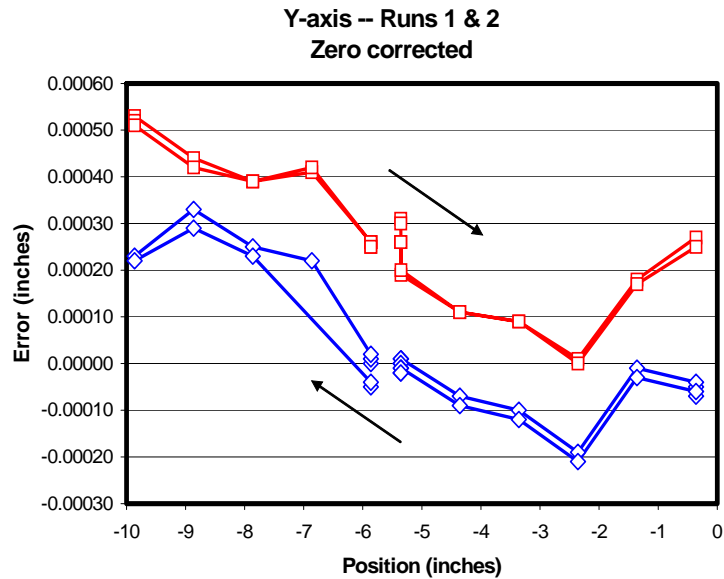
**Fig. 12 Position error vs Y-axis position. The data are the same as in Fig 7, but with the zero misalignment removed (see text). Red points are for increasing Y, blue points for decreasing Y.**

Fig. 12, the same data are re-plotted with this zero discrepancy removed. The apparently vertical grouping of several points near  $Y = -5.355$ " is expanded in Fig. 13.

Over relatively large distances, typically  $> 6"$ , the position accuracy measured with the laser interferometer was outside the specified  $\pm 200 \mu\text{in}$ . In the Y direction, from Fig. 12, the ingoing position at Y = -10 is off by  $700 \mu\text{in}$  relative to the outgoing position at Y = -2.3. In the X direction, from Fig. 14, the ingoing position at X = 0 is off by  $1,700 \mu\text{in}$  relative to the outgoing position at X = -14.

The laser interferometer should be used to measure the motion of the machine while it follows the same tool path used for the test pieces.

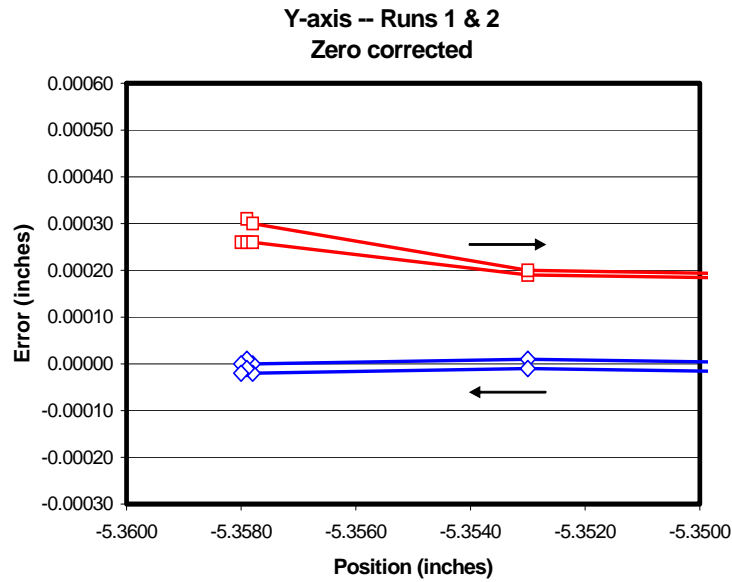
**Fig. 13 Data of Fig. 12 expanded about  $Y = -3.355$  to explain the apparently vertical grouping of several points in Figs. 11 and 12.**

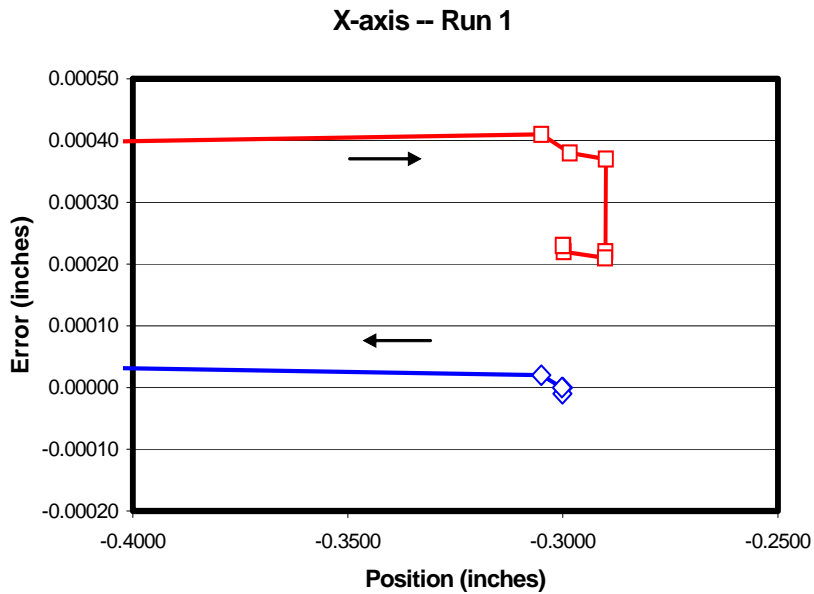
Figure 14 shows the measured position accuracy of the mill in the Y direction. The apparently vertical grouping of several points near  $X = -0.300$ " is expanded in Fig. 15.

**Fig. 15** Data of Fig. 14 expanded about X = -0.30 to show the details of the apparently vertical grouping of several points.
