TITLE: DIGITAL CONTINUUM RECEIVER HARDWARE MODIFICATIONS

AUTHOR(S):   D. Schiebel

DATE: January 6, 1982

This technical note is intended to describe the changes to the digital continuum receiver hardware. The continuum receiver was designed by J. Ray Hallman and is described in EDIR No. 188.

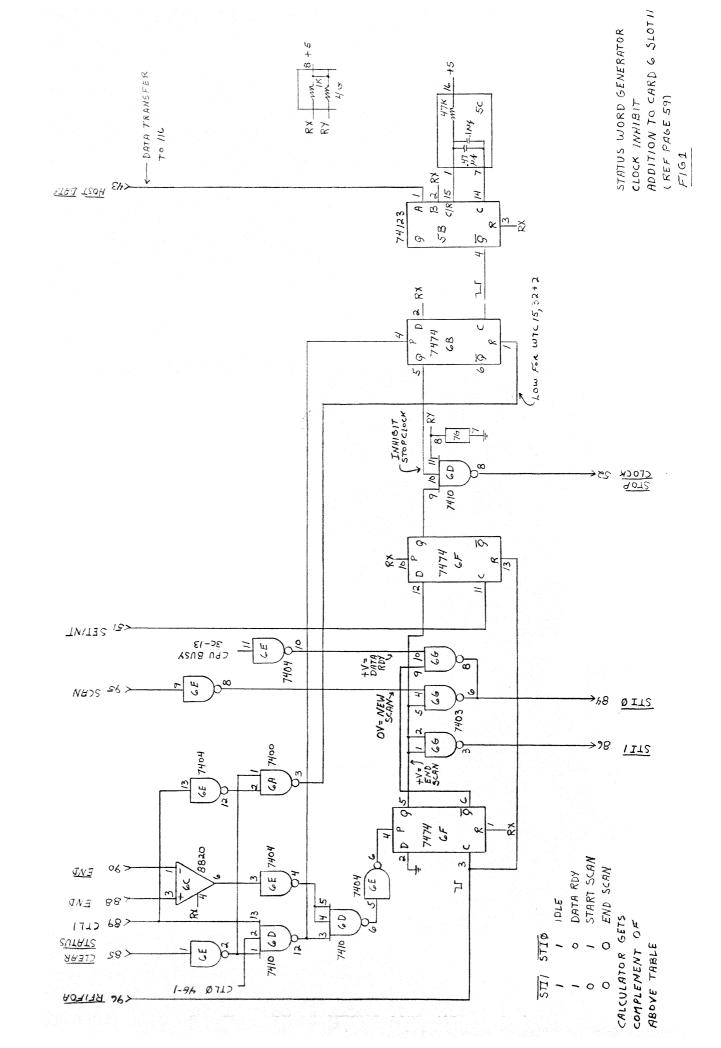
The host computer interrupt structure was changed a great deal as far as the receiver hardware was concerned. First the data interrupt occurs only when data is ready and the new center of integraiton interrupt has passed. In addition, an extra interrupt (required by 300-ft DDP 116 program) is generated at the end of the scan.

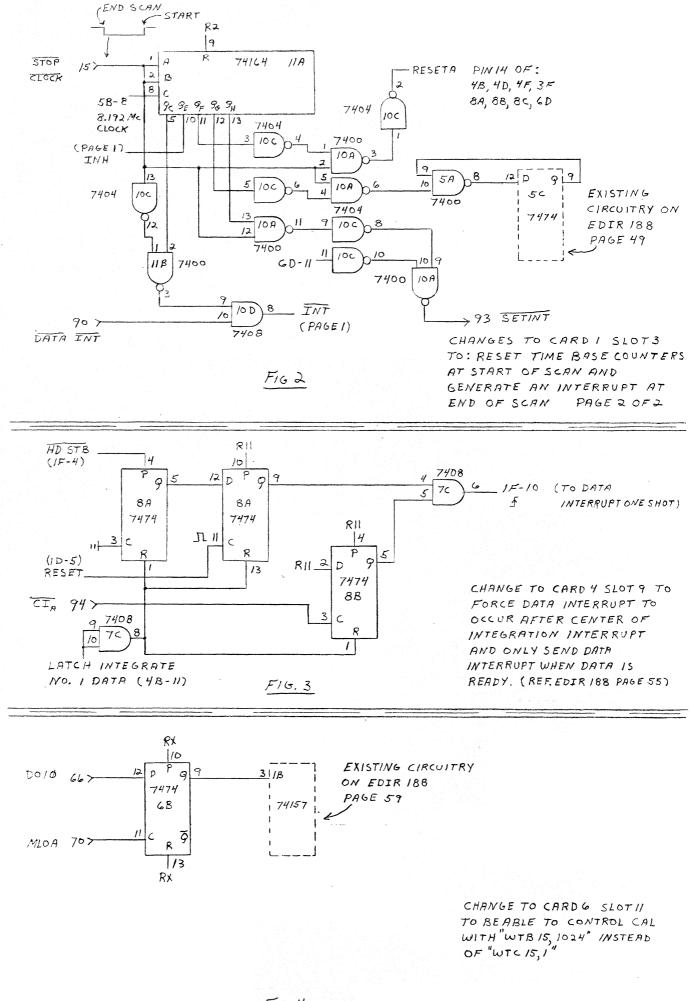
FIG 5

To generate a center of integration interrupt was rather an involved hardware addition. This was complicated by the fact that the host computer (300-ft DDP 116) only had one interrupt line that had to be shared as a data and center of integration interrupt. The approach used was to provide a flag $\overline{CI}$ (reference Figure 5) to tell the host computer that it was a center of integration interrupt.

The logic of Figure 5 was implemented to generate a center of integration interrupt. The basic idea of the logic was to provide a duplicate phase counter (EDIR 188, page 49) and the samples/integration counter (page 55) and run these

counters at twice the frequency as in the normal counters. When these counters count down to zero it would be half way through the integration period and would generate an interrupt.

ADDITION TO CARD 1 (SLOT 3)

TO GENERATE CENTER OF
INTEGRATION INTERRUPT
PAGE 1 OF 2
(REF. PAGE 49)

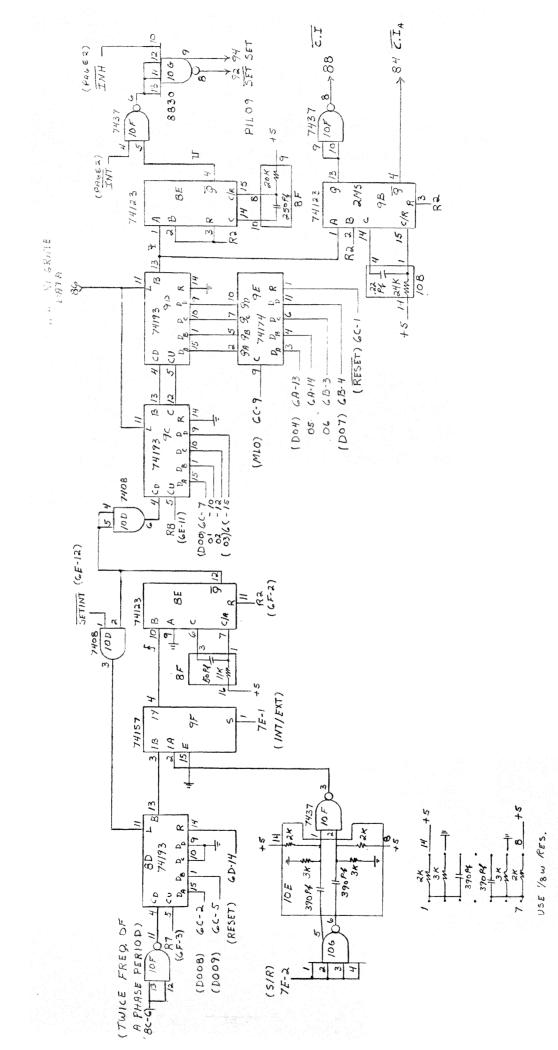
This flag caused a problem in that if a data interrupt should happen to occur while the flag was still set the host computer would interpret that interrupt as another center of integration interrupt. The logic in Figure 3 takes care of this problem by forcing the data interrupt to occur after the $\overline{CI}$ flag is gone.

CHANGES TO CARD 1 SLOT 3
TO: RESET TIME BASE COUNTERS
AT START OF SCAN AND
GENERATE AN INTERRUPT AT
END OF SCAN   PAGE 2 OF 2
